# Debris/Ice/TPS Assessment And Integrated Photographic Analysis For Shuttle Mission STS-46

September 1992

DEBRIS/ICE/TPS ASSESSMENT  
AND  
PHOTOGRAPHIC ANALYSIS  
OF  
SHUTTLE MISSION STS-46

July 31, 1992

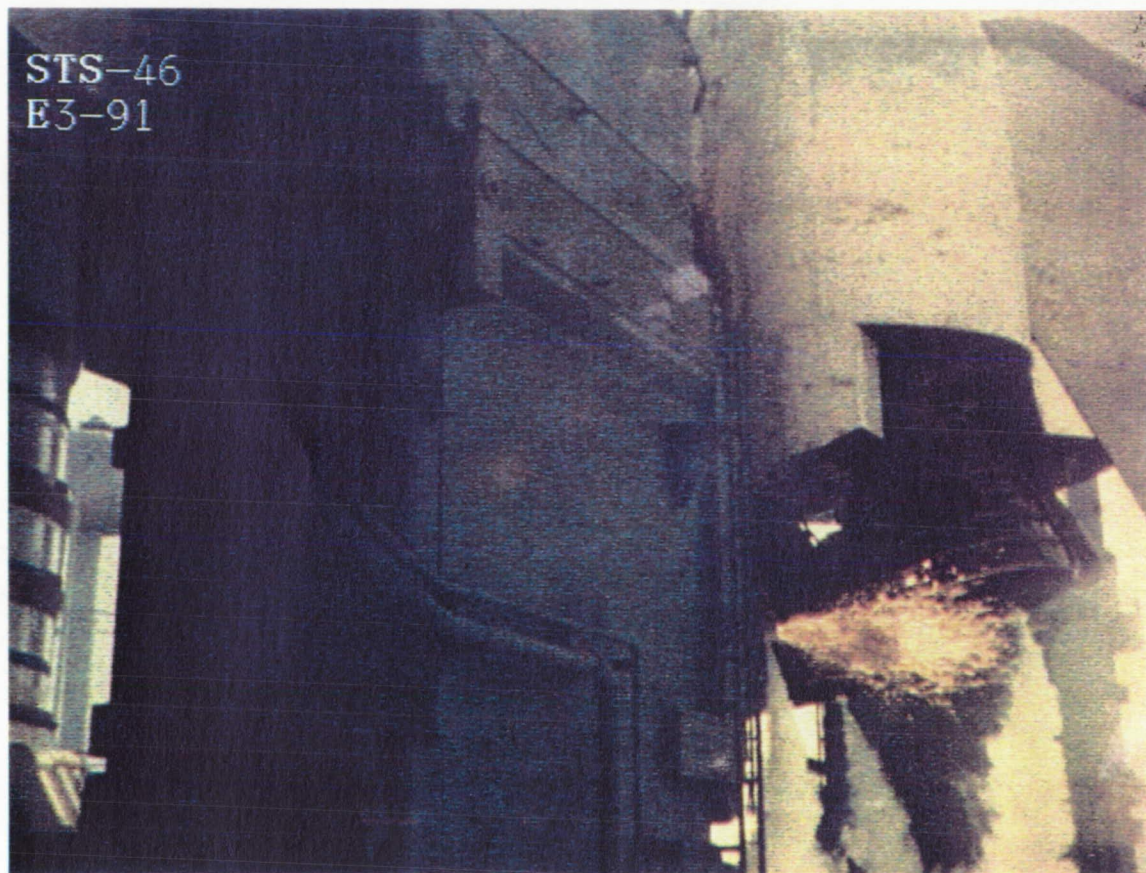
**Figure 2.2.1 Premature Firing of Hydrogen Igniter**

The southwest hydrogen igniter on the LH2 TSM fired too fast and ended prematurely (before SSME startup). The southwest hydrogen igniter stopped firing at T-8.634 seconds as read from the Camera E-3 film. No follow-up analysis is expected.

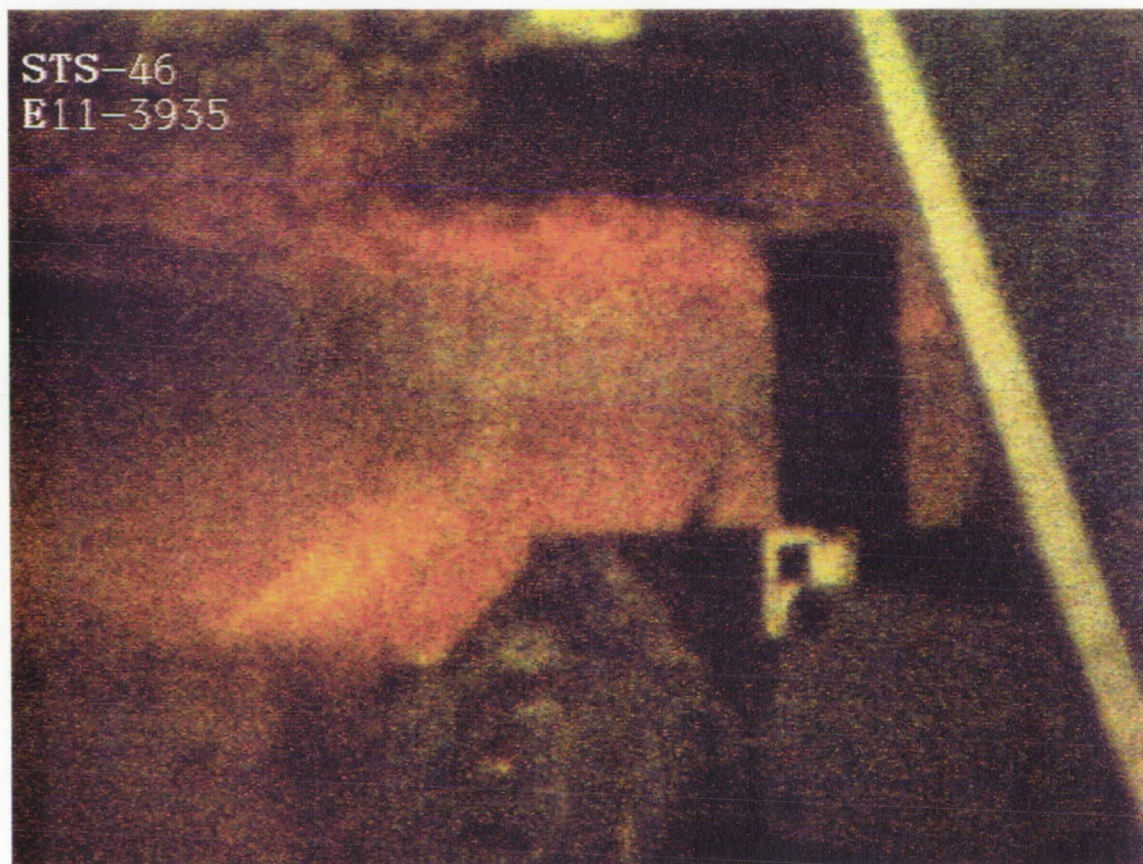
Figure 2.2.8 Bolt Hang-up at LSRB HDP M-7 During Liftoff  
(Camera E-011)

On camera E-011 a bolt hang up on the left SRB holddown post number M-7 was noted. The bolt hung up in the SRB debris containment system (DCS) area. The visible extent of the bolt hang up was measured to be 13.11 inches on the camera E-011 film where the bolt appeared to be at maximum extension. A review of previous occurrences of bolt hang ups since reflight was conducted. Bolt hang ups have occurred on six previous missions since reflight. Five of the seven bolt hang ups were on the RSRB. No further photographic analysis is expected.

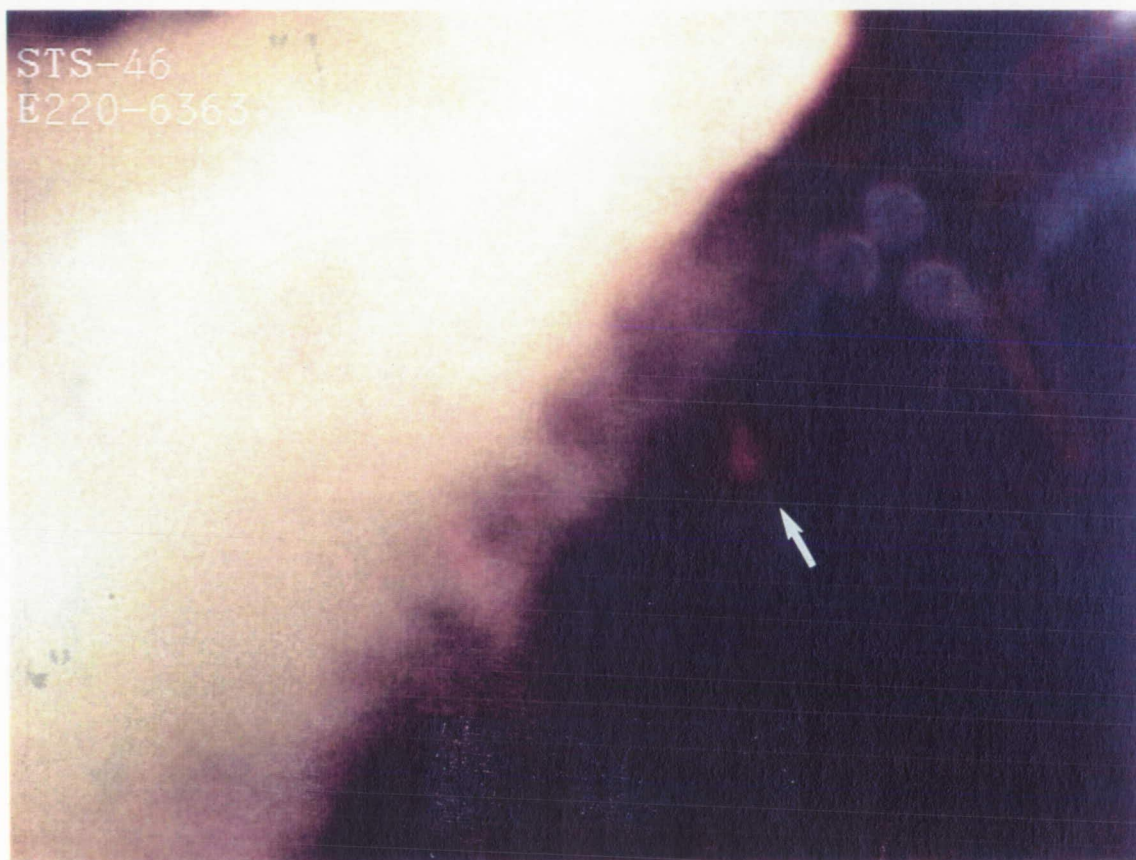
**Figure 2.3.3 Orange Puffs in SSME Exhaust Plume**

An orange puff was seen in the SSME exhaust plume at approximately 27.7 seconds MET and again at approximately 52.6 seconds MET (shown above) on the camera E-220 film. The cause of these puffs was not determined. No follow up action has been requested.
